**SUMMARY OF FACTS AND STATEMENT OF OPINION
F-22A ACCIDENT
20 OCTOBER 2005**

The accident board was convened to investigate the 20 Oct 2005 Class A accident involving an F-22A aircraft, S/N 03-4045, assigned to the 27th Fighter Squadron, 1st Fighter Wing, Langley Air Force Base (AFB), Virginia (VA).

On 20 Oct 05, at approximately 2030 local time (L) or 0230 Zulu (Z) at Hill AFB, Utah (UT), while preparing to take part in a Night Surface Attack Tactics mission, an F-22A, S/N 03-4045, ingested a Nose Landing Gear (NLG) pin into the right engine. After the pin was ingested into the engine, the mishap pilot (MP), Major Evan Dertien, immediately shut down the aircraft and safely egressed the aircraft (Tab V-2.12). There were no injuries. The damage to the aircraft was confined to the right intake, engine and related components. The loss was valued at \$6,754,275.36 (Tab D-2). Several media agencies were present at the time of the mishap due to the high interest in the F-22A program. Several inquiries were fielded at the time of the mishap however media interest has been minimal since then (Tab DD-3).

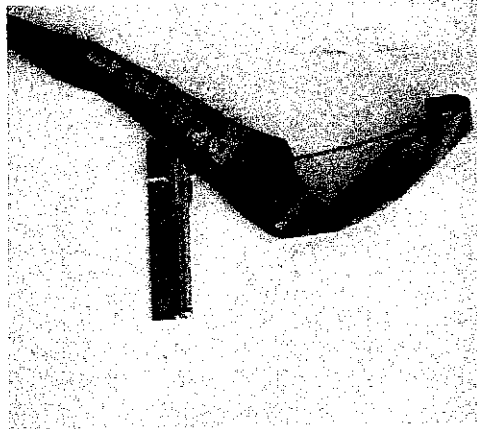
After the MCC replied that the pin had not been removed, the MCC directed the MP to shut down the left (#1) engine so he could remove the NLG pin. (See Figure 1.)

Figure 1 – NLG pin with lanyard and streamer

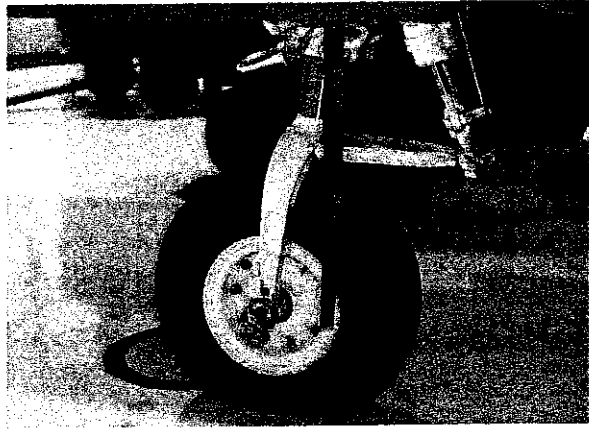
The MCC ensured his fire guard maintained visual contact with the pilot while the MCC disconnected communications and assisted the SES crew with removal of the servicing cart (Tab V-1.11). After removing the equipment, the SES crew cleared the area outboard to the right rear of the aircraft (Tab V-6.1; Tab V-8.1). The MCC moved "briskly" across to the left side of the aircraft and reconnected communications with the pilot (Tab V-1.11 thru V-1.12). The MCC glanced the aircraft over to see if everything was clear and ready for engine start. The MCC did not notice the NLG pin streamer (Tab V-1.17; Tab V-2.9). The NLG pin streamer was not tied to the NLG strut (Tab V-1.13). The streamer was to the rear of the NLG well and extended parallel to the NLG strut (See Figure 2).

Figure 2 – Example of the streamer's position at the time of the mishap

On 20 Oct 05, while the MCC accomplished launch procedures, the area around the mishap aircraft was very dark and winds were light (Tab V-2.6). The NLG pin streamer was dark red in color, approximately two to three feet in length, and lacked any reflective material (Tab V-1.22; Tab V-1.24). The color and lack of reflective material diminished the MCC's ability to spot the streamer as he visually scanned the aircraft. In tests conducted under similar conditions, the board was unable to discern the NLG streamer.

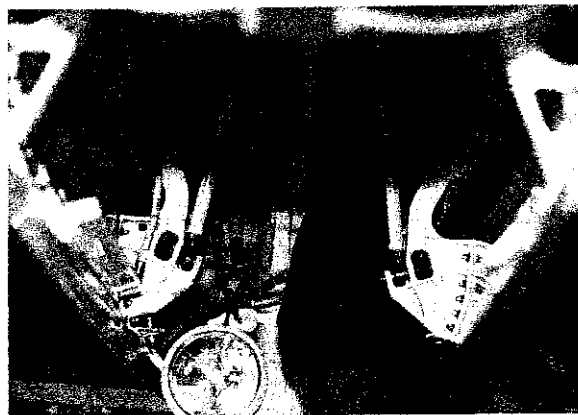
The MCC told the MP to shut down the left engine so that he could remove the NLG pin. After the RPM (rounds per minute) of the left engine was at zero, the MCC approached the left engine inlet, put his hand across the inlet to ensure there was no suction, and then he knelt down on the left side of the nose wheel well. The MCC extended his left arm fully to try to remove the nose gear pin but was unable to reach it (Tab V-1.12). (See Figure 3)

Figure 3 – Example of the MCC's first attempt to remove the NLG pin

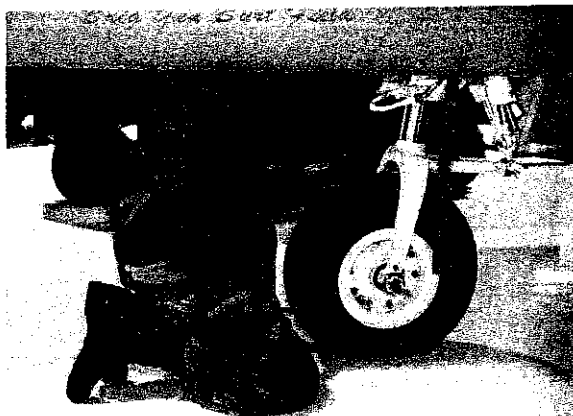
The MCC physically put his upper torso up into the gear well and used his right hand to remove the pin (Tab V-1.12). (See Figure 4)

Figure 4 – Example of an individual’s position as he attempts to remove the NLG pin
